Swan Hill Tourism & Cultural Hub

Design Update

SEPTEMBER 2023

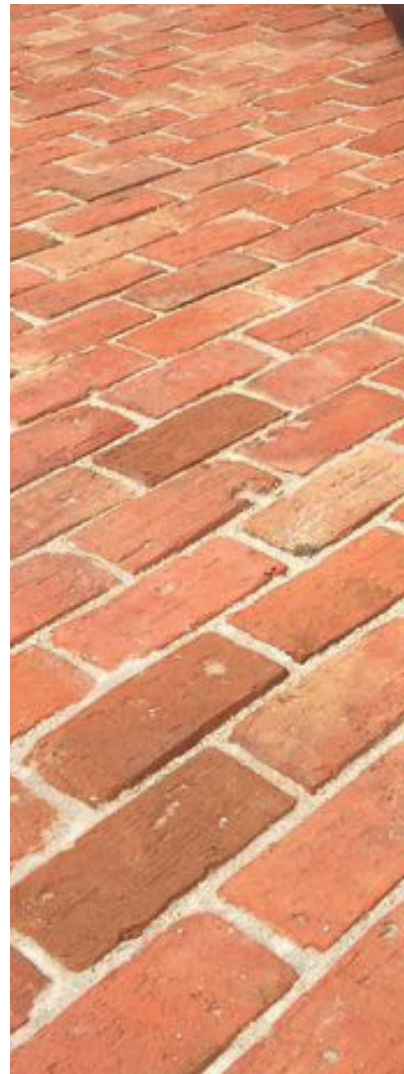
2. Red brick paver stretcher bond

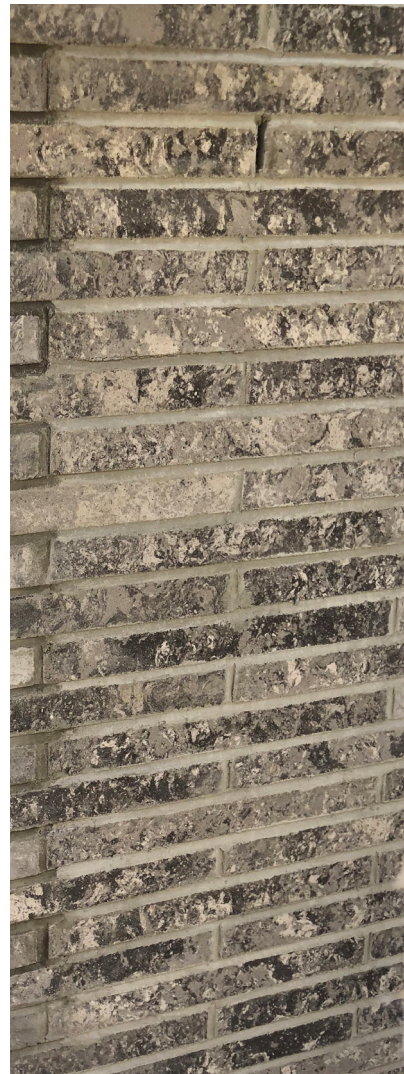
3. Mottled grey masonry brick stacker bond

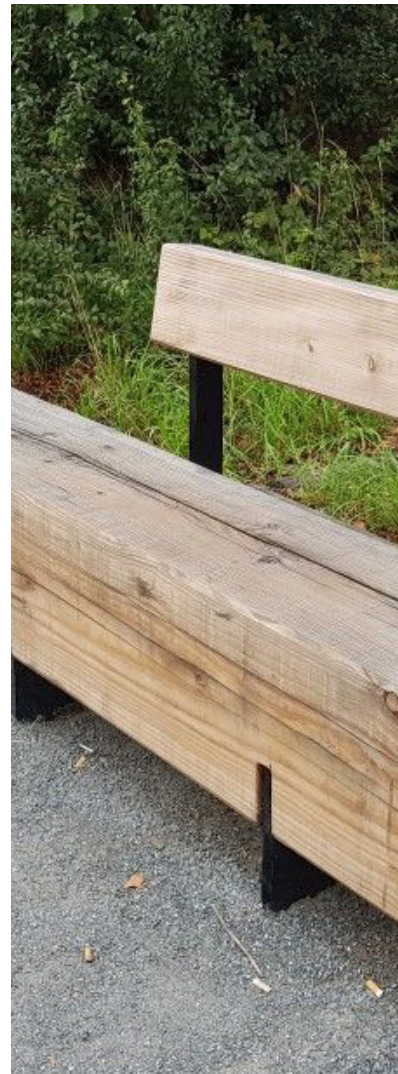
4. Milled hardwood timber seating block with inset powder coated steel

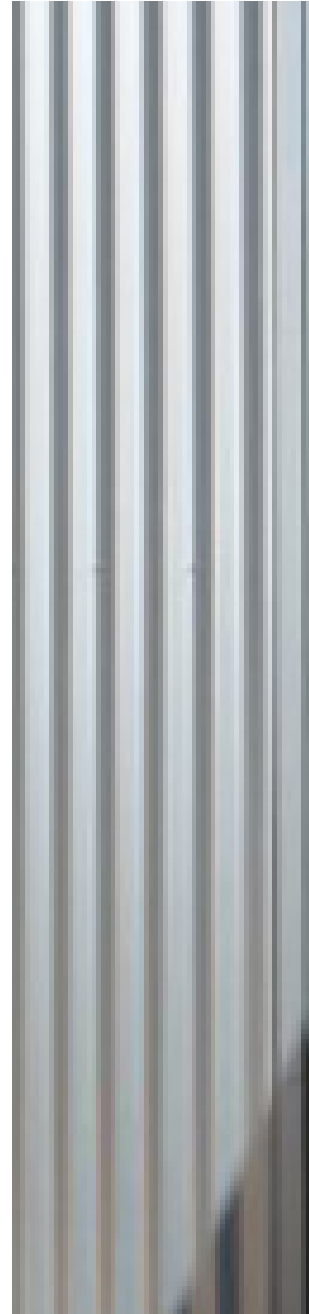
2. Heritage Zinc
Wall Cladding

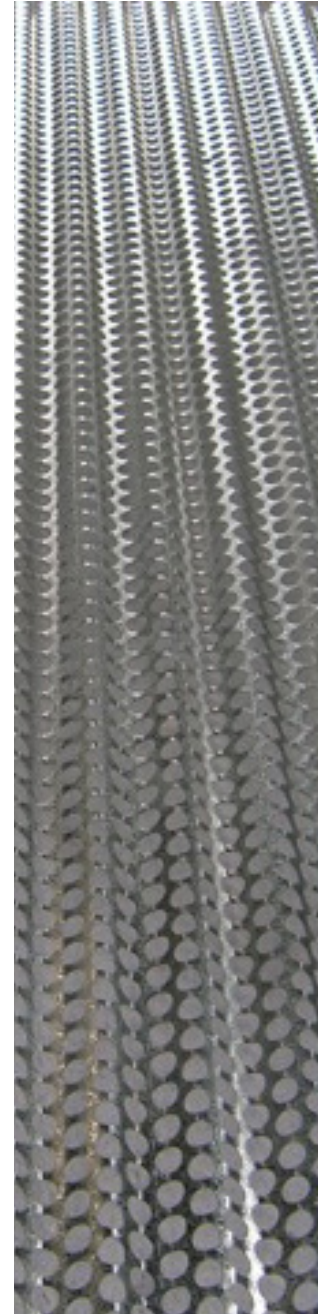
3. Perforated Heritage
Zinc visual screening

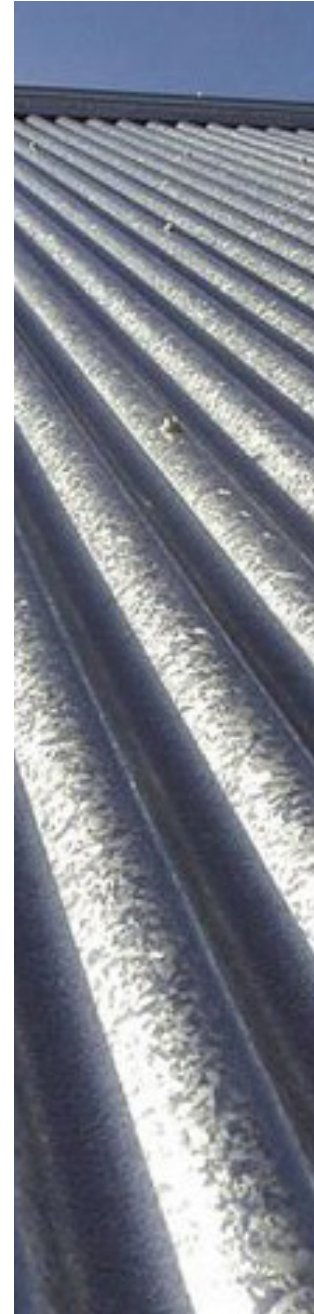
4. Heritage Zinc Roof
Sheeting
