**REPORT NO:** 3230600-1

**PROJECT LOCATION:** Visitor & Cultural Building  
Monash Drive  
SWAN HILL

**COMMISSION:** Carry out appropriate in-situ soil tests and observations at three locations as shown on the attached plan, to a depth of up to 3.0 metres.

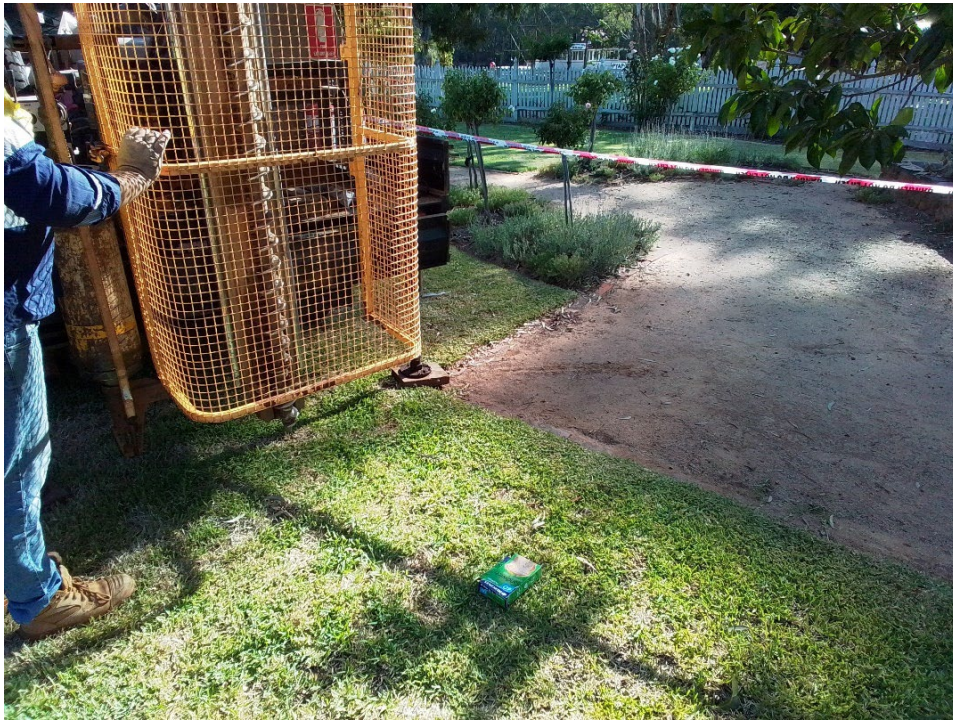
The ground surface over the site is relatively level. Groundcover consists of natural grasses, and introduced trees. A photograph of the site taken during the site investigation is provided in **Figure 1**.

**Figure 1:** Site photograph showing the existing site conditions.

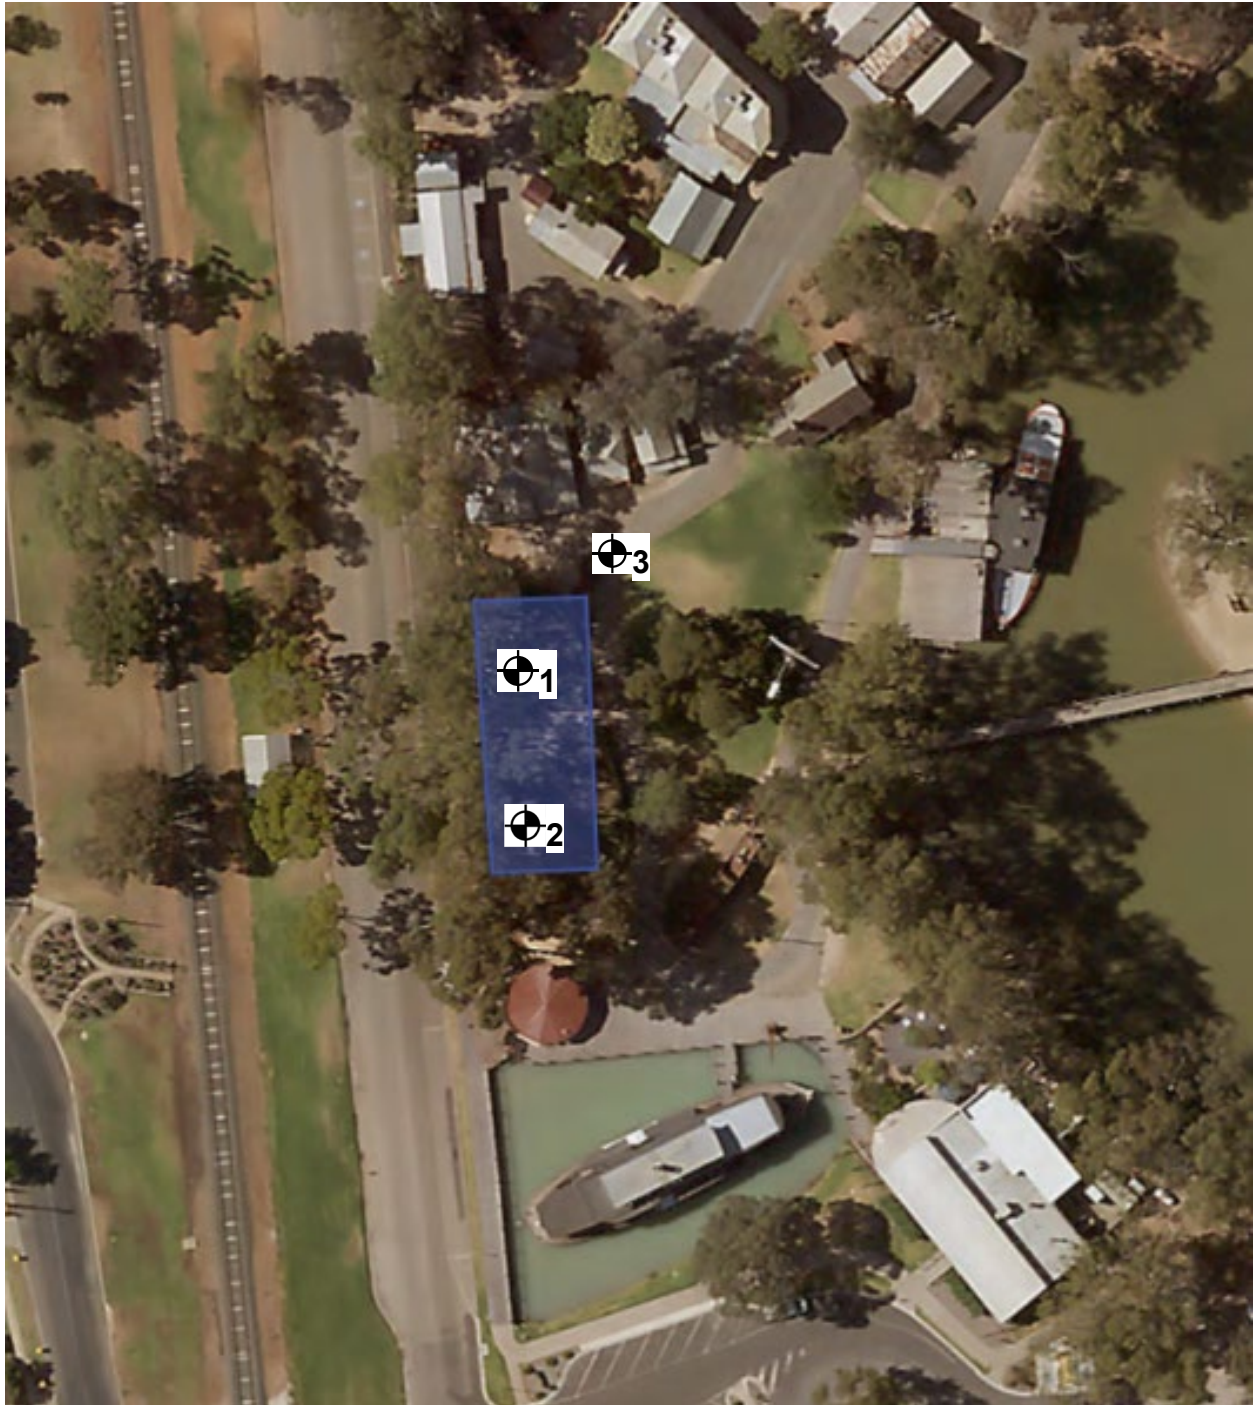
## LOCATION OF TEST SITES: VISITOR & CULTURAL BUILDING SWAN HILL

The fieldwork consisted of drilling three boreholes to 3.0 metres depth with a mechanical auger. The approximate locations of the boreholes are shown on the attached plan. Subsurface materials penetrated were visually classified to AS1726: Geotechnical Site Investigation. The engineering logs of each borehole are attached showing the soil descriptions and depths, along with any cohesive strengths measured and observed densities of non-cohesive soils.

Denotes Boreholes
